# Fortress Dömitz

*STRUCTURAL ELEMENT: SANDSTONE PORTAL*

Documentation of a Restoration and Repair Project

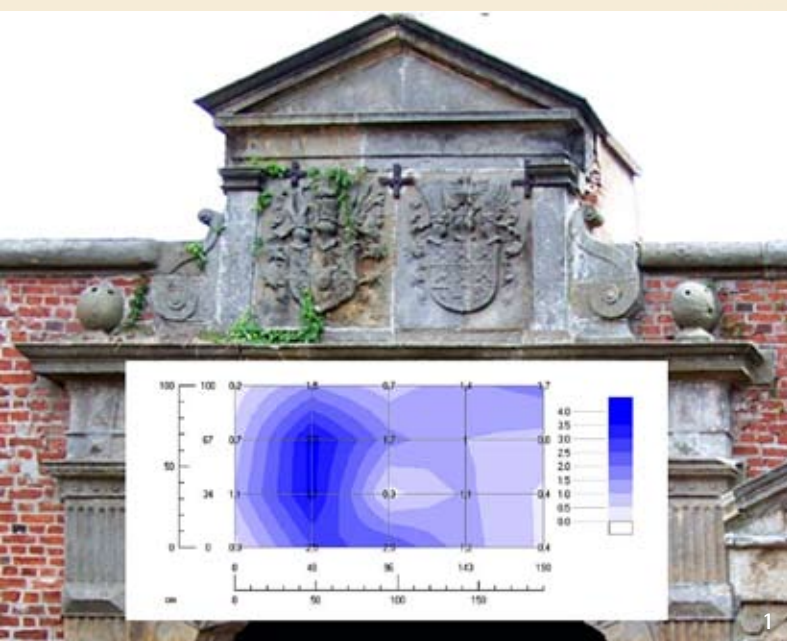
The salt analyses revealed that the salt content of the portal sandstone varies greatly. The area above the archway, for example, was found to have a salt content near zero, while a high content of structurally damaging salts was found in the jambs and pilasters owing to rising damp from the adjacent brickwork.

Fig. 1 – Measurements taken in the coat-of-arms area of the top portal section

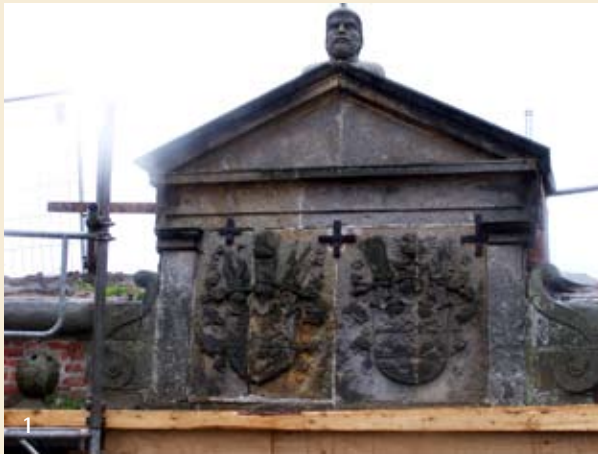
Fig. 1 - Soiling and blackening on the surface of the sandstone

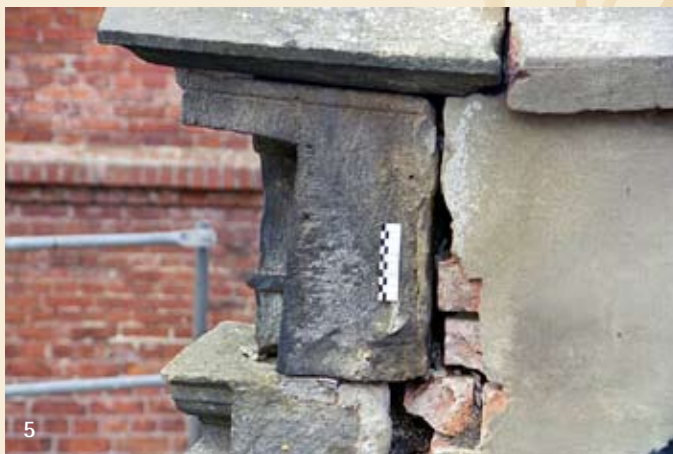
Fig. 5 - Displacement in the top section of the portal above the gateway

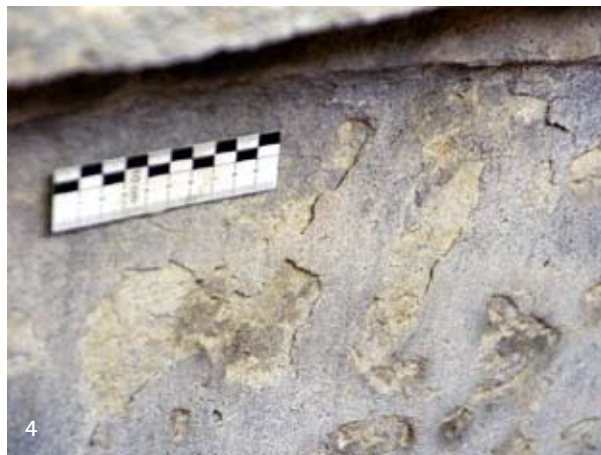
*Fig. 2 - Broken off section of repair material*

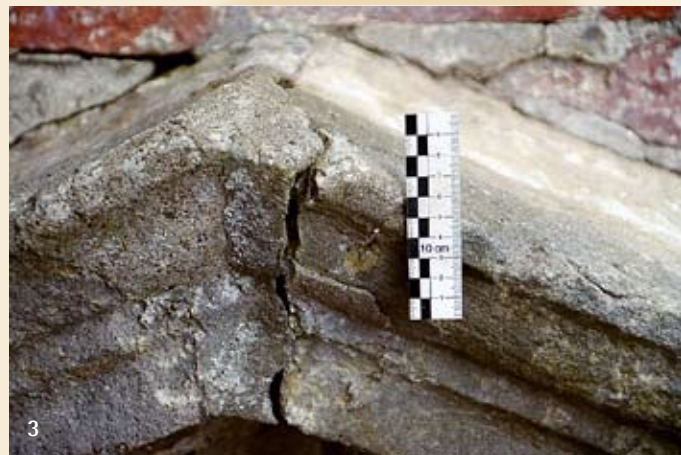
*Fig. 4 - Cracks in mortar repair work*

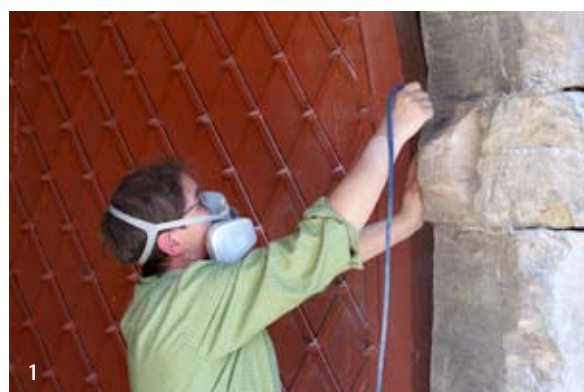
*Fig. 2 - Pilaster following cleaning work, with reference areas showing the condition of the surface prior to cleaning*

*Fig. 1 - Micro-abrasive cleaning*

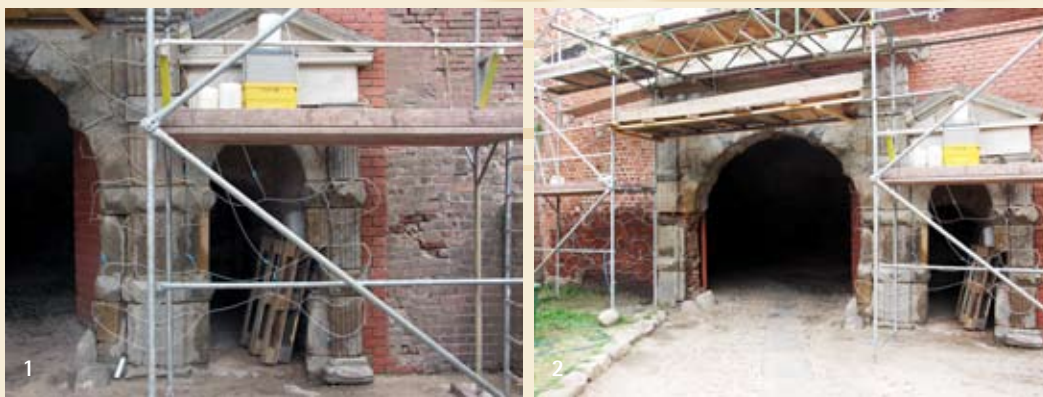
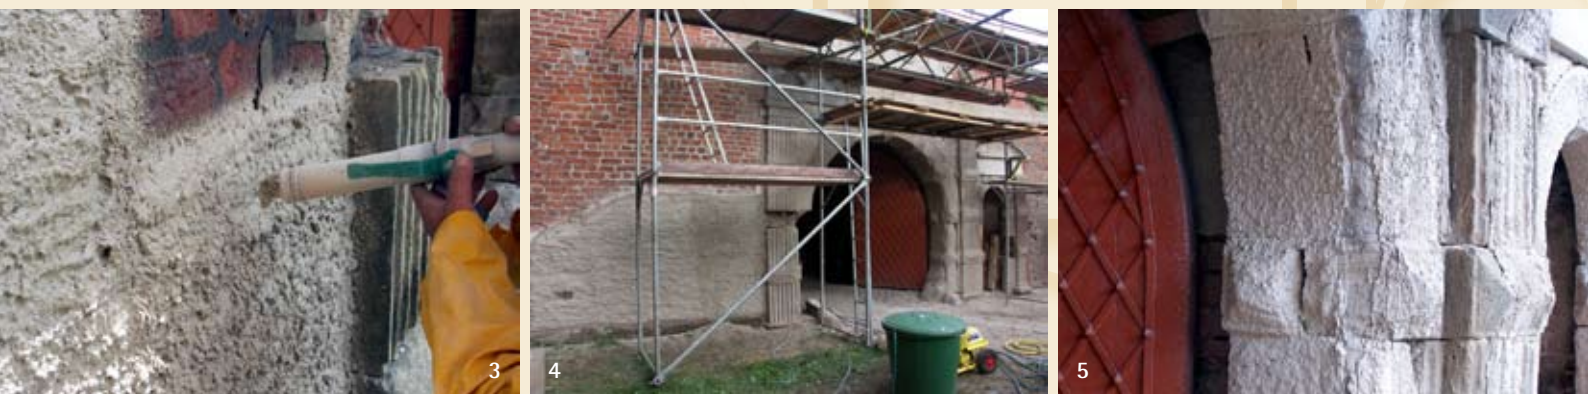
The sandstone blocks which form the pilasters and the jambs on either side of the gateway and side entrance were found to have high salt contents in some parts. The identified salts were a mixture of various nitrates and chlorides. Furthermore, along with gypsum, a relatively high sodium sulphate content was detected in some areas. This type of salt known to be especially damaging to building materials.

*The poultice material is sprayed onto the cleaned surfaces of the sandstone and adjacent brickwork using a small plastering machine.*

*Fig. 3 - Application of desalination poultice*

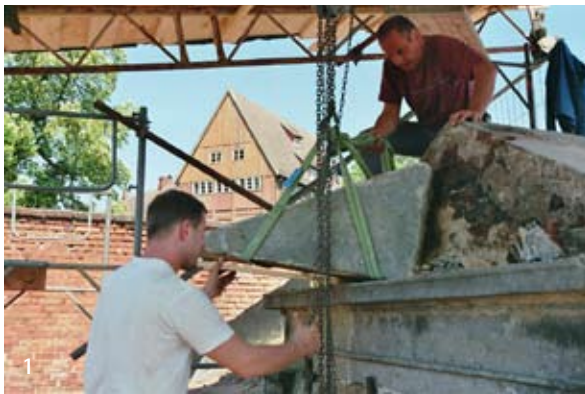
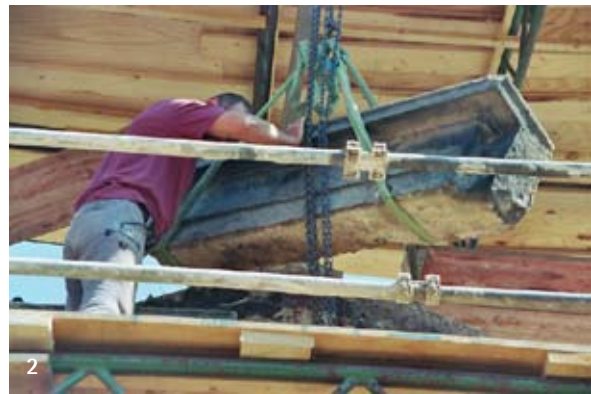
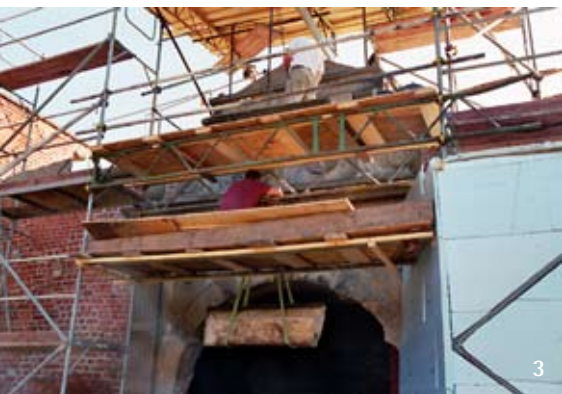
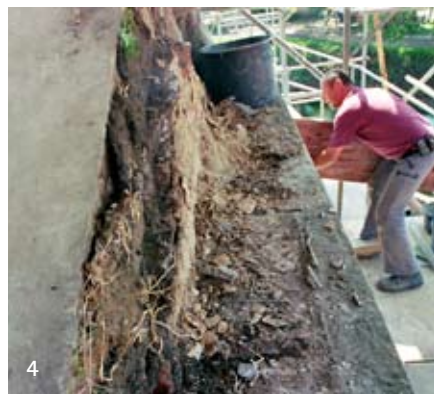
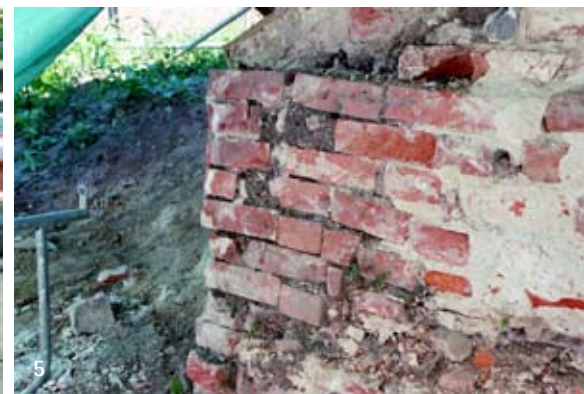
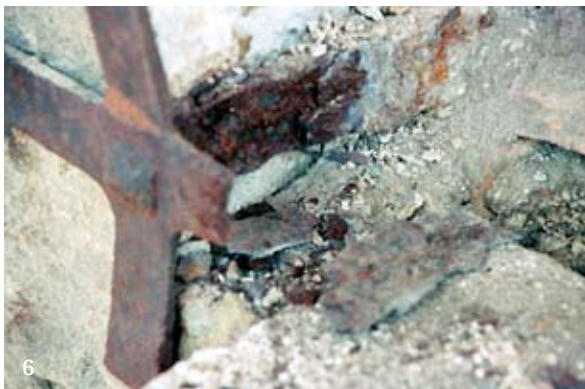
The masonry units of the coat of arms cartouche above the gateway, with the flanking volutes and the pediment, exhibited displacements of up to 4 cm. As a result of this displacement large gaps had formed between the masonry units and the brick wall behind them as well as in the joints between stones. These gaps had filled with humus. Plants were growing in this humus, and their roots were exerting pressure on the masonry units and contributing to additional displacement of the structure.

*Fig. 6 - Corroded anchor on the pediment*

Therefore this entire portal section, down to the cornice, was dismantled and the structural elements re-set.

The solid masonry units were initially re-set, or re-laid, without mortar onto sheet-lead spacers. The masonry units were stabilised with anchors, braces and dowels made of 316 stainless steel (V4A) or brass. The joints between the masonry units were then sealed with tow (hemp) and filled in with liquid mortar. After the bedding mortar had set the tow was removed and the joints tuck-pointed. The three visible wrought-iron anchors of the coat-of-arms cartouche were restored and refastened.

*Figs. 1-3 - Dismantling of the pediment above the gateway*

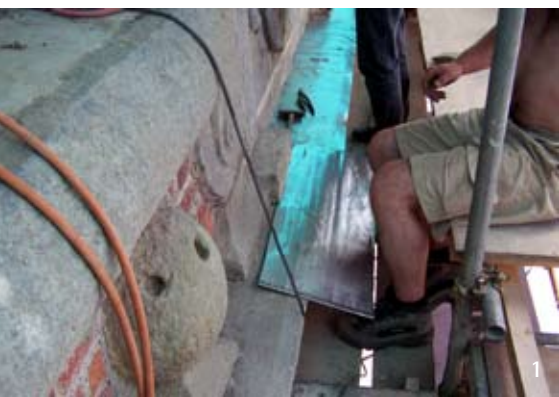
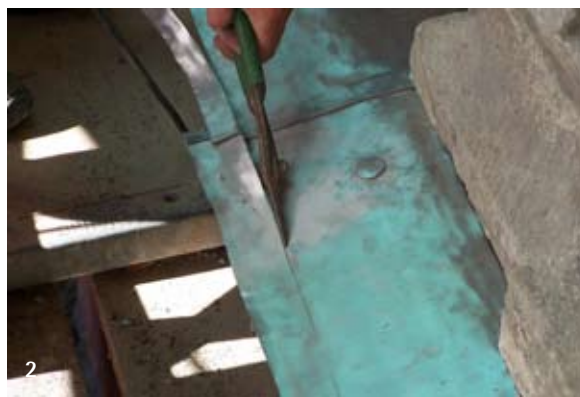
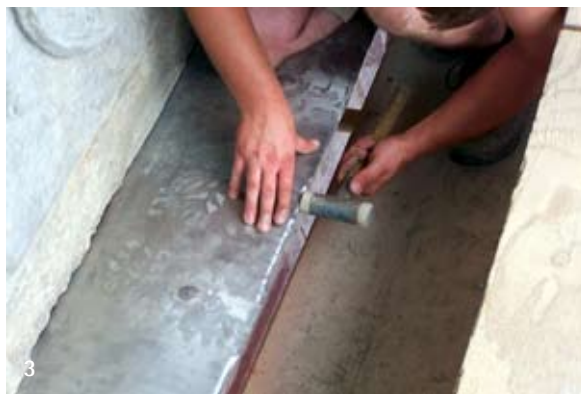
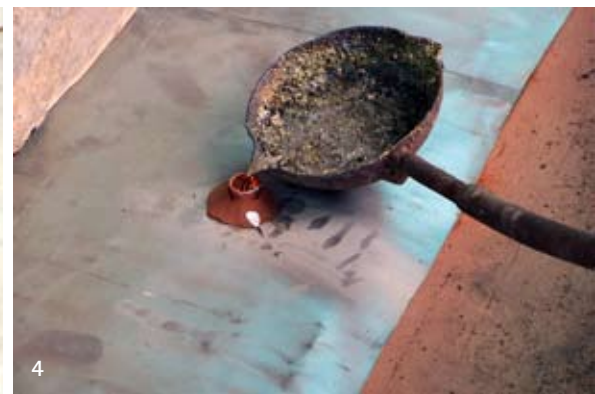
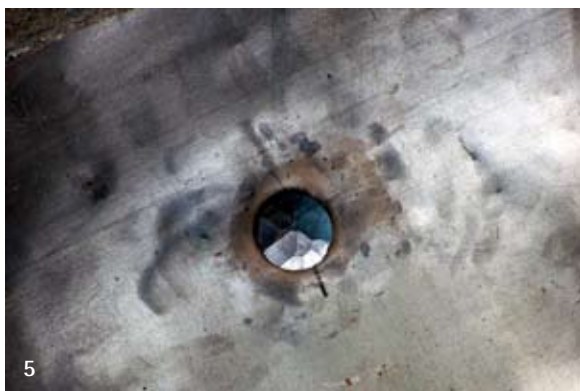
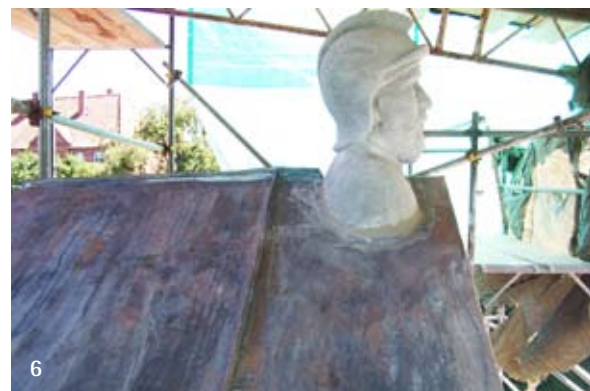
In addition to the rising damp and the moisture migration from the brick wall of the bastion, rainwater penetration was identified as another major cause for the weathering damage experienced by the sandstone structural elements. Therefore the top surfaces of the pediments above the gateway and the side entrance were covered with a layer of sheet lead (1.0 mm) for water run-off. In order to avoid blurring or distorting the profile lines the coverings were formed without locking strips and with a narrow protruding edge (approx. 1 cm).

*Figs. 1-3 - Application of the sheeting*

*Figs. 4/5 - Fastening of the sheeting with traditional melted lead*

*Fig. 6 - Sheetting on the top surface of the upper pediment*

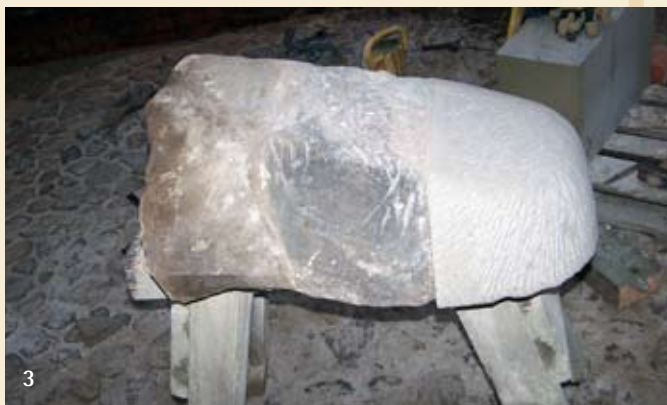
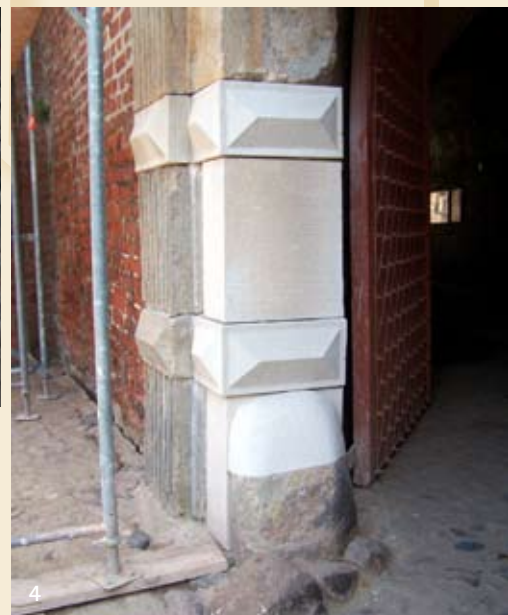
*Figs. 1/2 - Left jamb following the removal of old stone grafts and cement-mortar repairs*

Masonry unit replacement implies the complete removal of a masonry element and replacement with a newly fabricated element. This measure was required in the left pilaster of the sandstone portal, on the jamb of the gateway, and on the frieze and lower cornice of the pediment above the side entrance.

*Fig. 3 - Replacement of the upper section of the guardstone inside the left jamb*

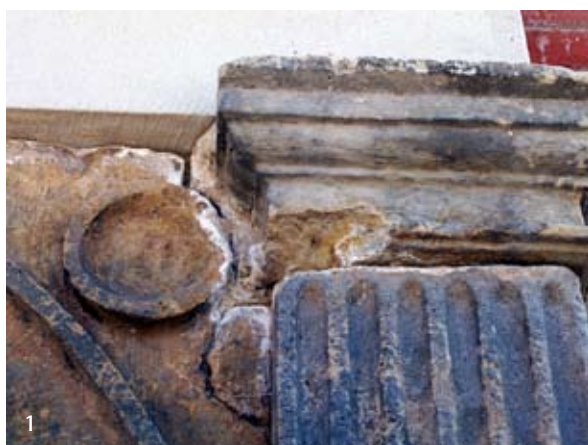
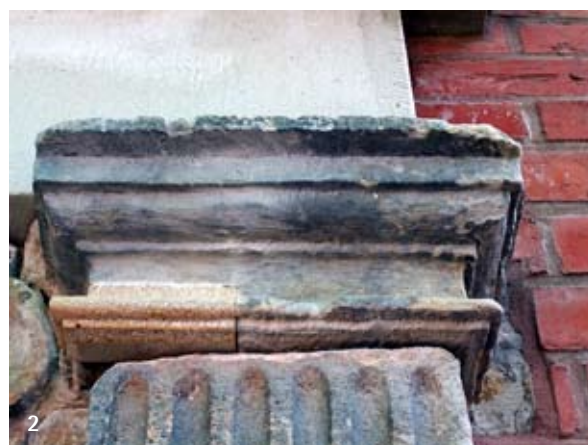
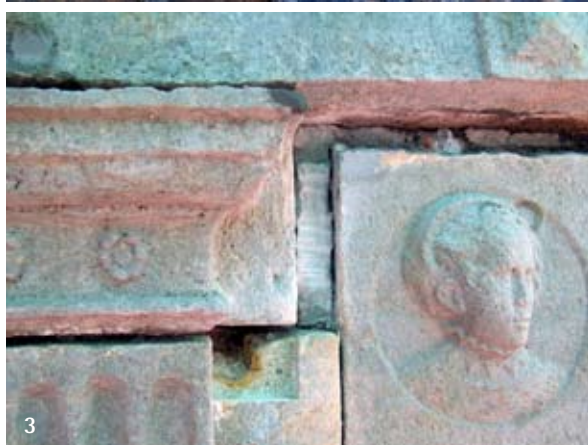
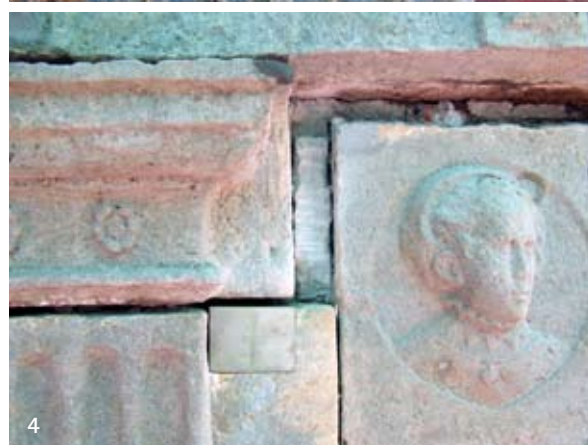
During earlier restoration work on the portal large flaws were repaired with stone grafts or filled in with plastered brickwork. Cotta-type Elbe sandstone was used for the stone grafts. The properties, in particular the weathering properties, for this type of sandstone differ greatly from those of the sandstones used for the original structure (Posta-type Elbe sandstones). All of the stone grafts made from Cotta sandstone were already showing signs of significant weathering damage.

These stone grafts, as well as the plastered brickwork, were removed and replaced with newly fabricated stone grafts.

The new stone grafts were made from Posta-type sandstone from the Mühlleite quarry; the macroscopic and physico-mechanical properties of this sandstone were found to be very similar to the sandstone of the original structure.

*Figs. 1-4 - Stone grafts on pilaster and in the architrave area*

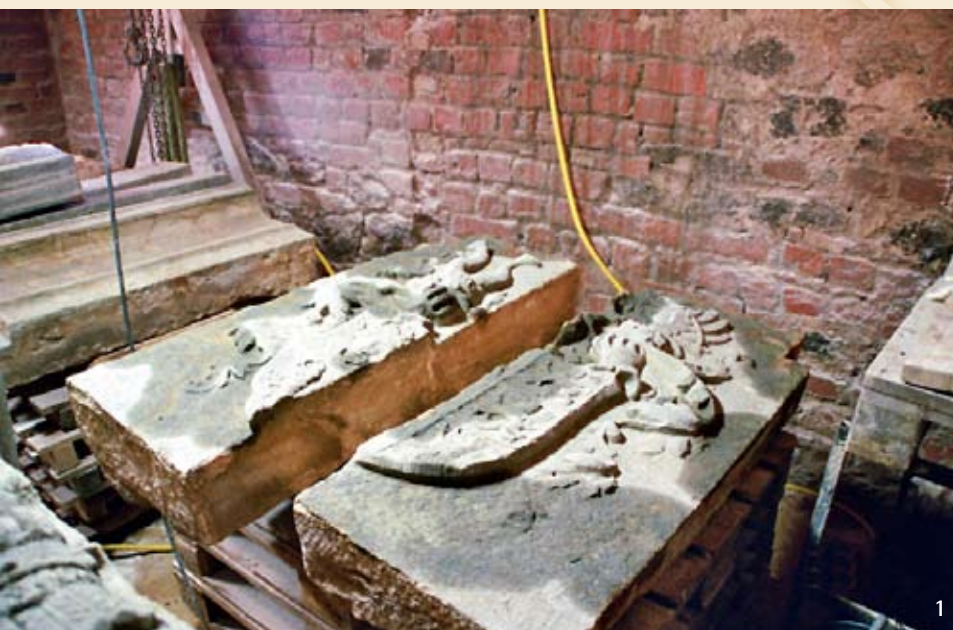
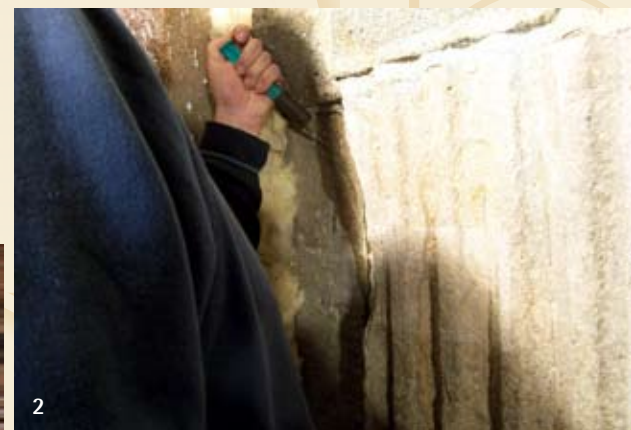
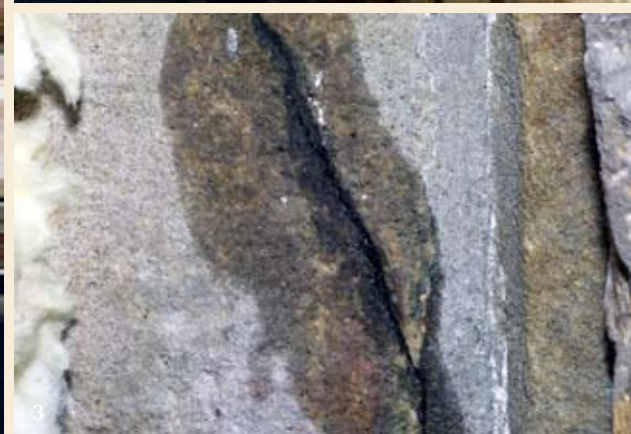
*Fig. 2 - Application of injection material using a syringe*

*Fig. 3 - Crack following the application of injection material. The discolouration around the crack from the preliminary moistening with silicic acid ester recedes after the ester has fully cured and dried.*

An injection mortar composed of silicic acid ester, fillers and glass beads in a fixed ratio was used for filling in smaller cracks and backfilling hollow layers and large scales. The injection mortar was mixed well to disperse individual components and then injected into the cracks and hollow layers with injection syringes; these areas had been pre-moistened with silicic acid ester prior to the application of the injection material. The silicic acid ester is used here as a binder which functions in the same way as in the strengthening treatments: through the secretion of an amorphous silica gel that cements the aggregates together and to the flanks of the cracks.

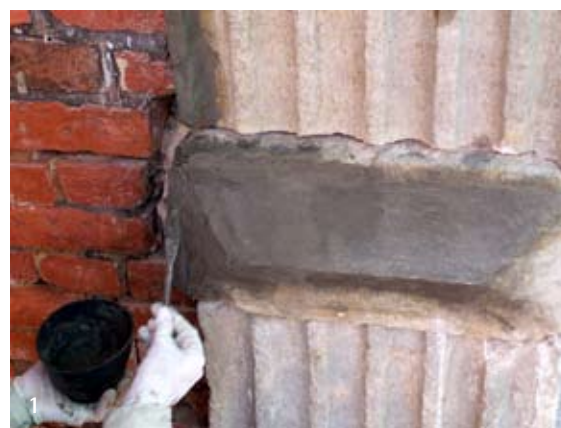
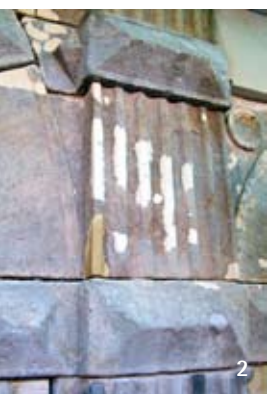
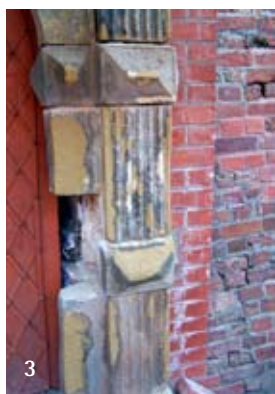
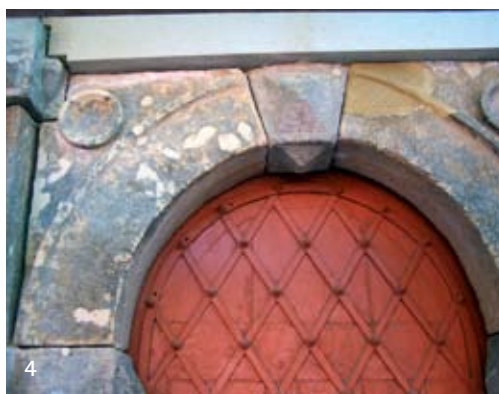
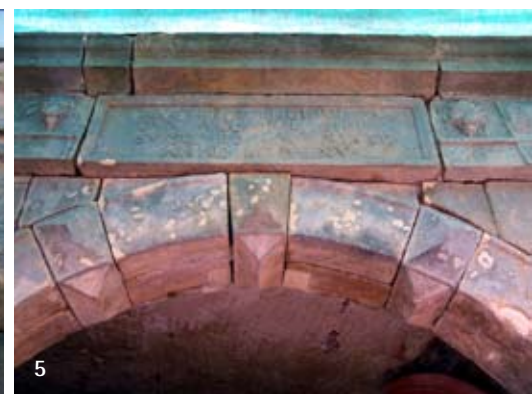
*Figs. 1-5 - Patching flaws with stone repair mortar*

A stone repair compound with a silicic acid ester binder was used for closing small to medium-sized flaws and areas of back-weathering as well as filling in spaces around plates of detached stone and contour scaling. In order to improve the adhesion of the repair mortar the surface of stone to be repaired was pre-moistened with SAE, and a bonding agent was applied.

The patches were made flush with the surface. Shallow flaws only required a single application of material to attain the required level. For larger repairs, however, the material was applied in layers. In this case the surface of the lower layer was roughened before the next layer was applied in order to avoid leaving solid and smooth surfaces which could inhibit proper bonding.

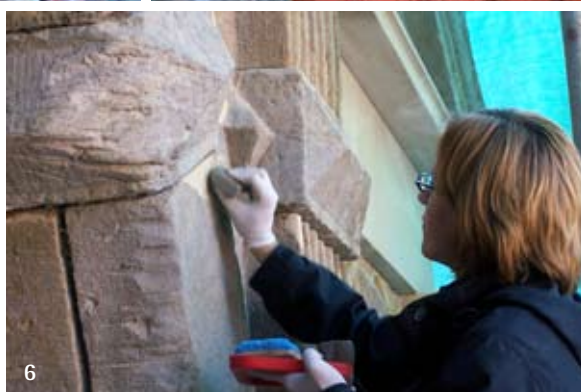
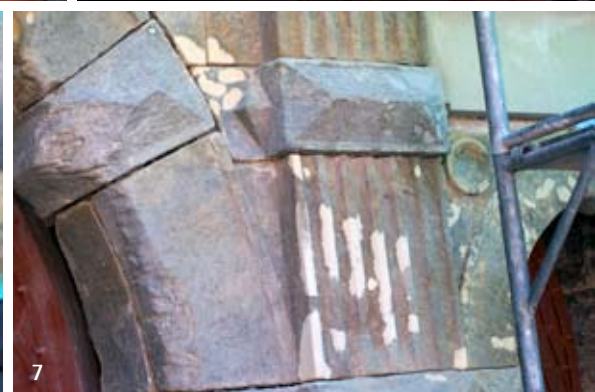
*Figs. 6/7 - Retouching repair work*

The stone repair compounds used for the repair work were matched to the colour of the surrounding rock. For this purpose pigments were added to the dry mortar. Because the sandstone colour and degree of patination can vary greatly the repair compound was later retouched to harmonise with the adjacent rock.

This process involved the application of colour to the patches using dry silicate chalks; various shades of chalk were mixed on the surface of the patch to match it to the surrounding area. This retouching work was then fixed using a silicic acid ester.

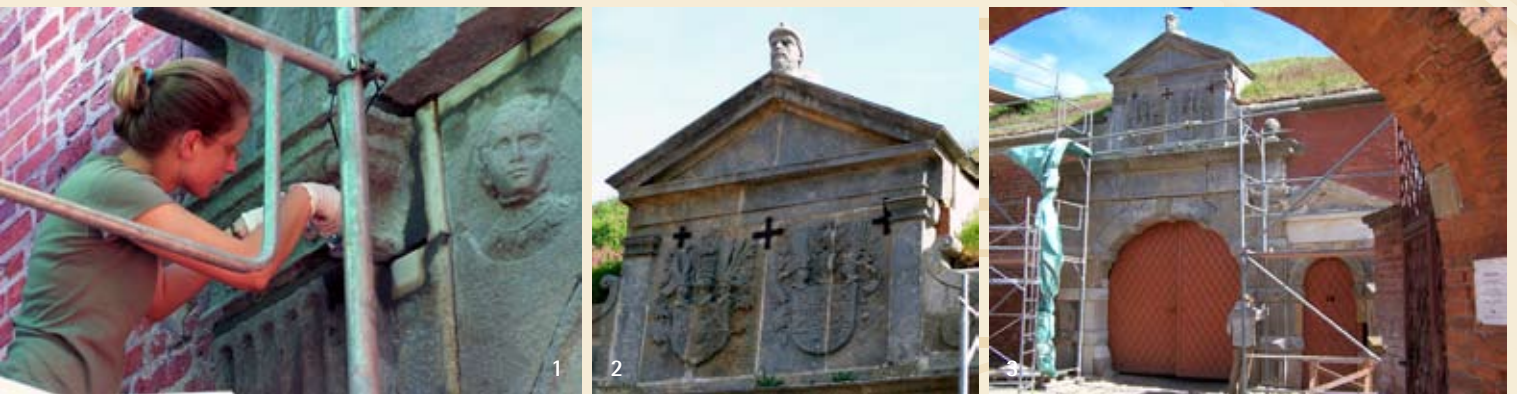
Fig. 1 - Filling of joints with mortar

Fig. 2 - Pediment after completion of repair and jointing work

Joints with either damaged bedding/pointing mortar or cement mortar were cleaned out. For this work the old joint material was carefully chiselled or scraped out by hand. Then the joints were thoroughly cleaned, and all dust residues were blown or suctioned out.

The earth-moist jointing material was pressed into the joints using pointing irons. After the curing process had begun the material was touched up with a scalpel to make the mortar flush with the surface.

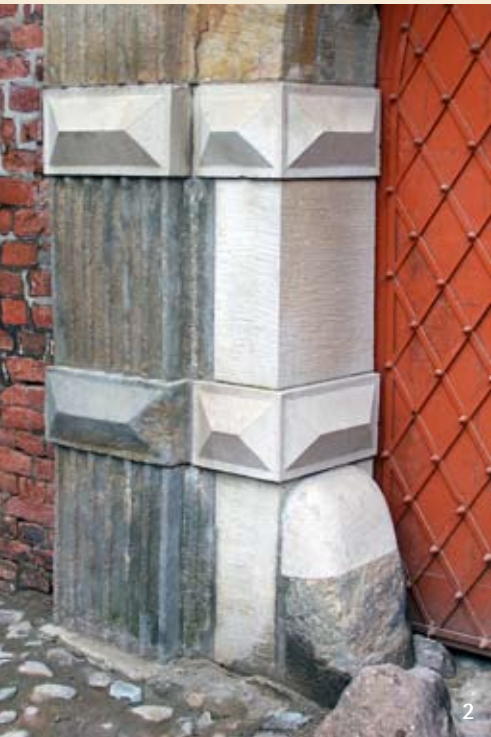
Fig. 2 - Repaired gate jamb

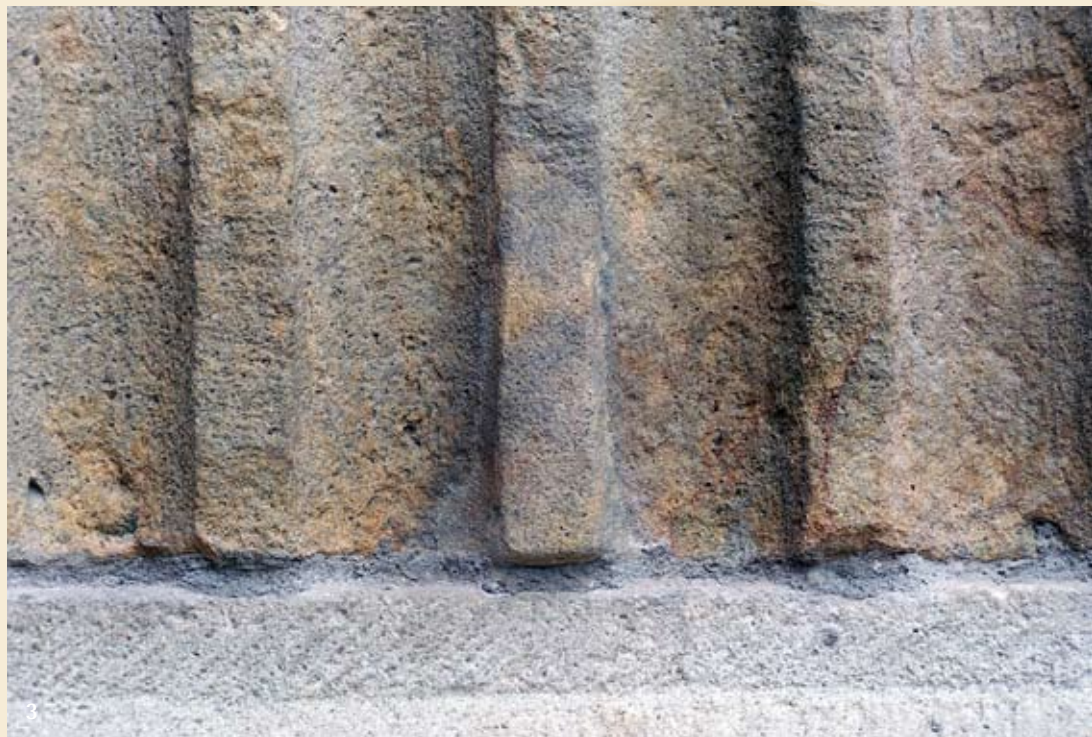
Fig. 3 - Repair work with stone repair compound on the pilaster to the right of the gate

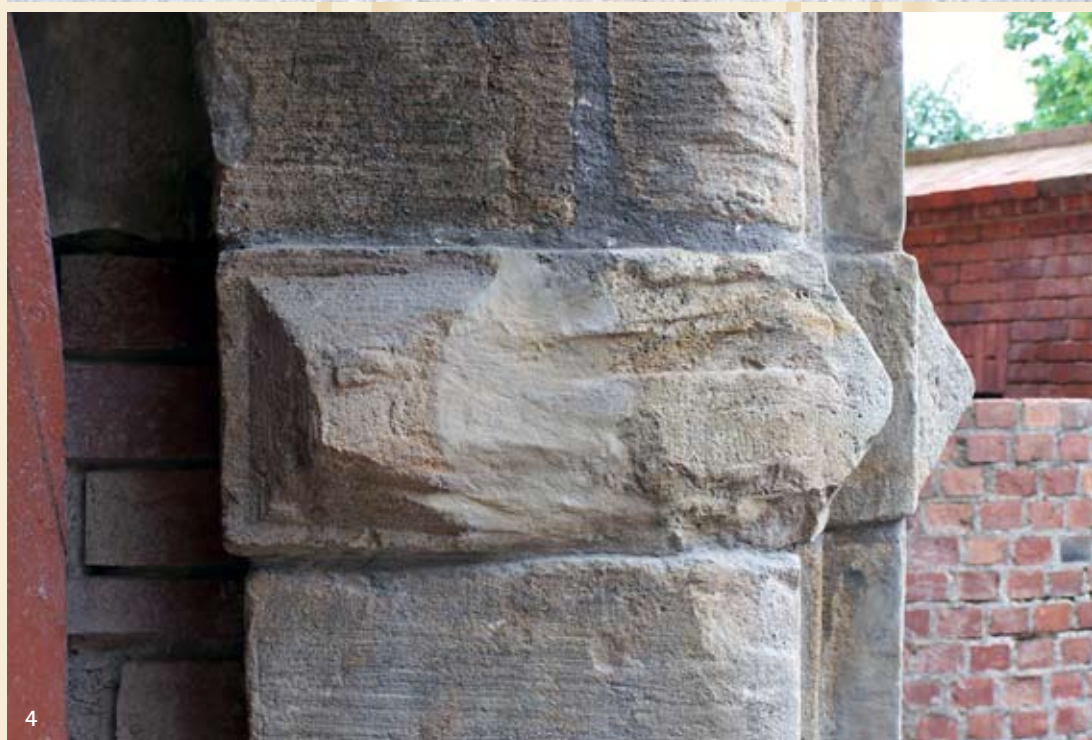
Fig. 4 - "Traces of use" preserved on the jamb of the gateway and conservative repair of break out

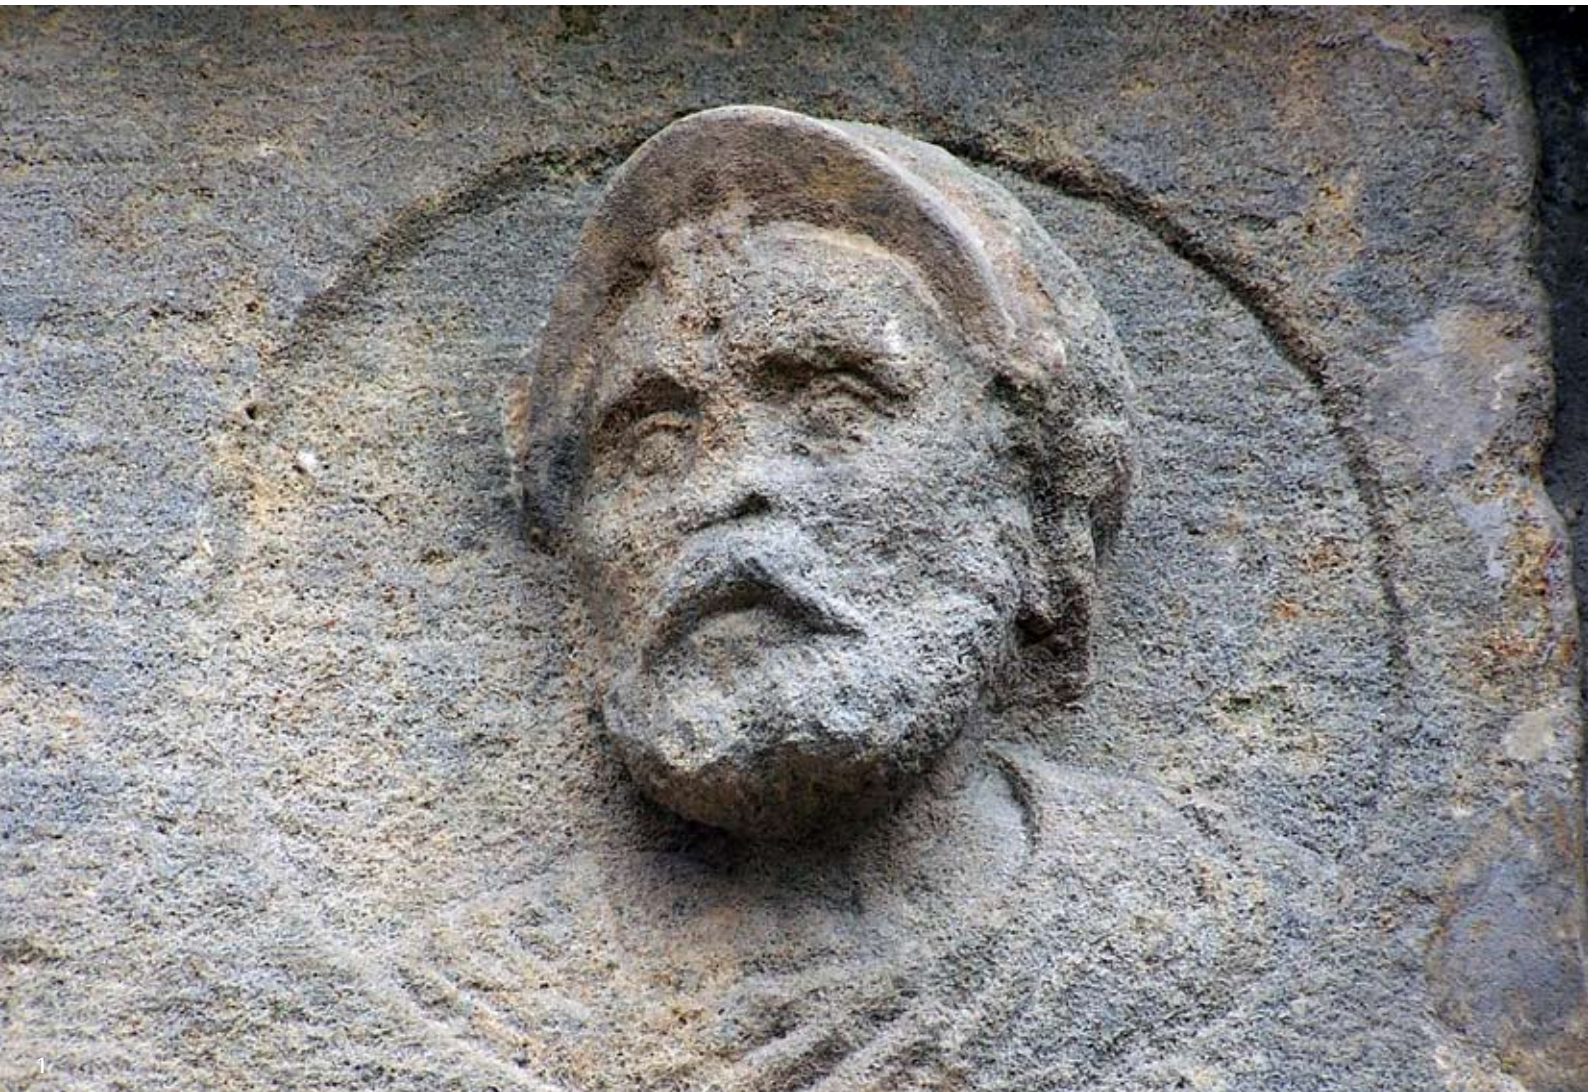
*Fig. 1 - Portrait medallion with warrior, break-out on helmet patched with stone repair compound*

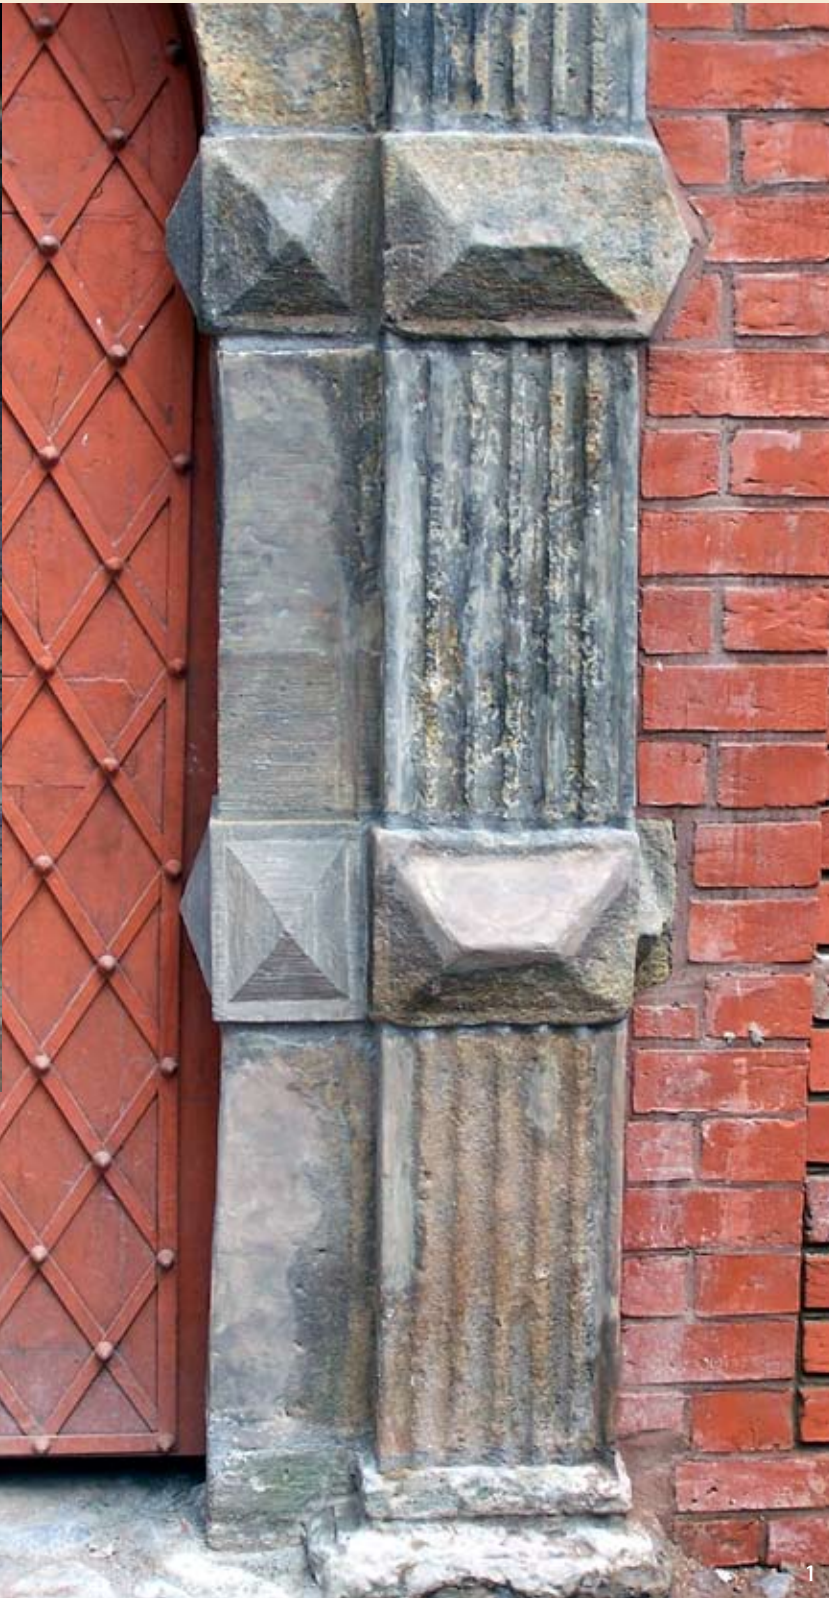
Fig. 1 - Side entrance jamb

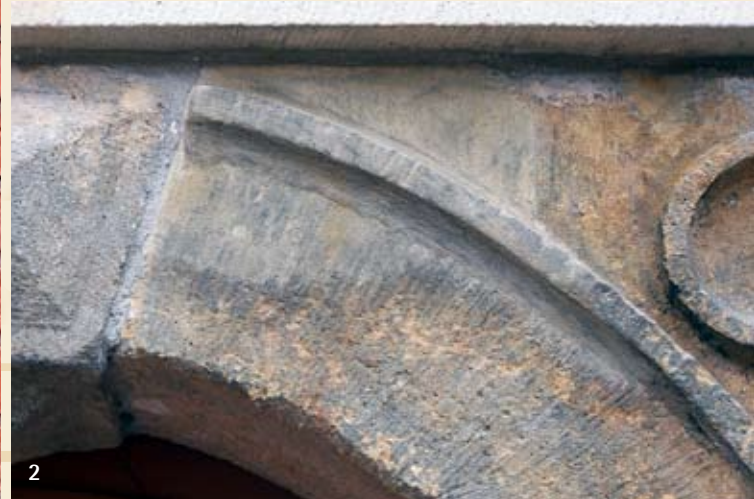
Fig. 2 - Patch with stone repair compound on side entrance arch
